DERRYLEA MINE, CO. GALWAY: NEW FEATURES EXPOSED DURING ROADWORKS

by Jerry O'Sullivan, Barry Flannery and Matthew Parkes

Abstract: During the summer of 2009, blasting of a new cutting for the N59 road at Derrylea Lough exposed some additional workings not previously recorded during the MHTI Survey of 2006. This brief article records these workings, as the excavations have now destroyed them. Additional data on the mineralogy was also provided by fresh rock cuttings. *Journal of the Mining Heritage Trust of Ireland*, 9, 2009, 31-32.

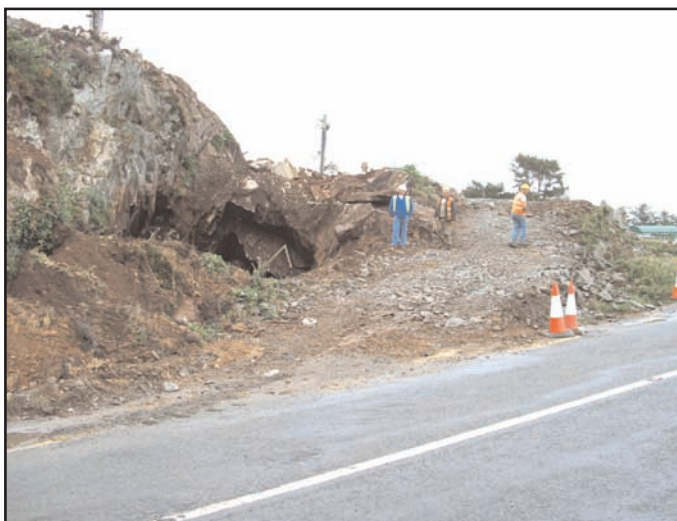
Figure 1. The initial excavations and bulldozing expose a new underground working. All photos by Jerry O'Sullivan. Figures 2, 3. Right. Two closer views of the blasted area showing the small working.

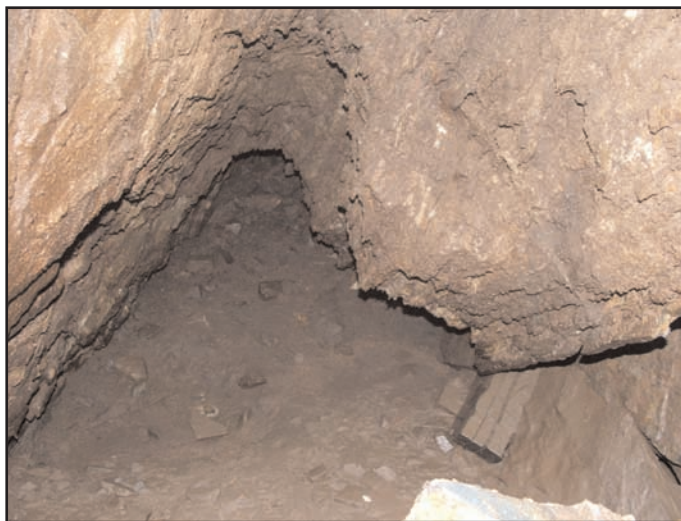
Figure 4. A view over the steep spoil or back fill bank into the mined cavity, with camera held at arm's length above the head by Jerry O'Sullivan.

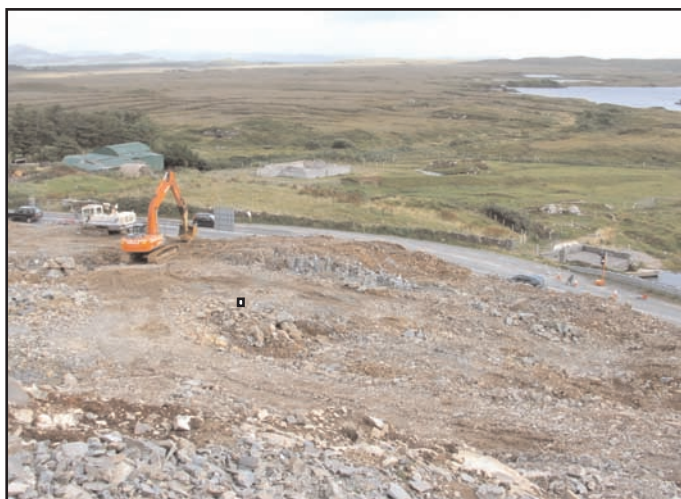
Figure 5. A view of the rock slope as it was being reduced to remove the bend at Derrylea. The former mine workings ran across the slope from left to right in mid slope

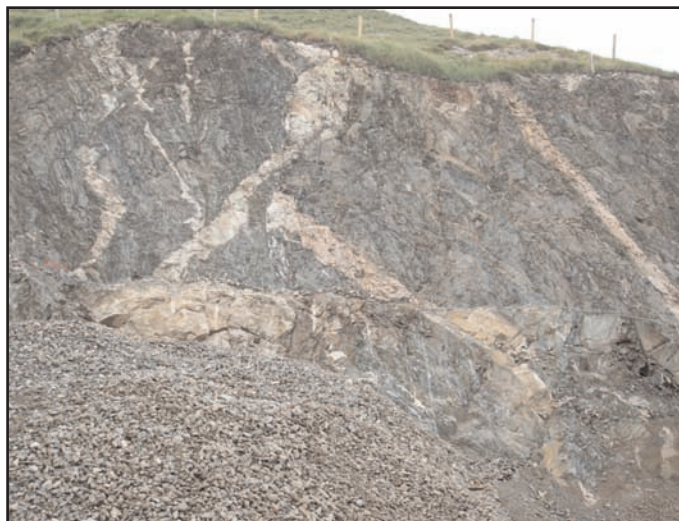
Figure 6. A view of the rock face at the late stages of cutting the new road section.
