# HISTORICAL RECONSTRUCTION DRAWINGS OF THE COPPER COAST MINES, CO. WATERFORD

By Dr Daniel Tietzsch-Tyler

**Abstract:** For the half-century between 1828 and 1878, the Co. Waterford coast east of the village of Bunmahon was the site of intense mining activity and the export of significant volumes of copper ore. As part of the development of the *Copper Coast Global and European Geopark*, two drawings were commissioned to interpret how the principal sites of mining operations might have appeared at the height of this activity. The first drawing attempts to reconstruct the site at Tankardstown where the copper ore was brought to the surface after 1850 as it might have appeared in about 1870. The second drawing attempts to reconstruct the site of the ore dressing floors beside Knockmahon village as it might have appeared in about 1860. The main mine buildings at Tankardstown have recently been partially restored, but almost nothing now remains of the formerly extensive dressing floors. This article presents an illustrated commentary to facilitate an exploration of the mine sites as reconstructed. *Journal of the Mining Heritage Trust of Ireland*, 5, 2005, 29-46.

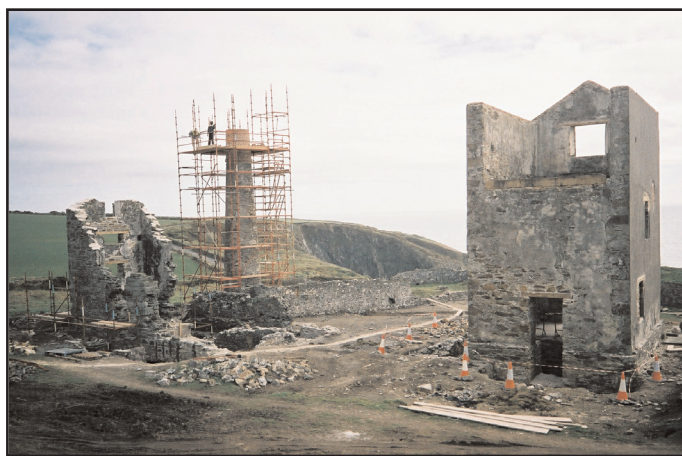
**Figure 1.** Tankardstown pumping engine-house (right), winding engine-house and chimney (looking towards the sea).

To pump the mines dry, a large rectangular engine-house was built beside the shaft (Figures 1 and 15:G). The engine-house stands almost complete today, with the damage seen in *The McKenzie Break* now restored. The building has an entrance in both of its shorter walls. One overlooks Heron's Shaft and the other, which has a fine restored semi-circular brick arch, faces the road below windows on two levels. Several windows punctuate the longer walls to light the three floors inside that were reached by stairs - the lines of which are still visible on the inside walls.

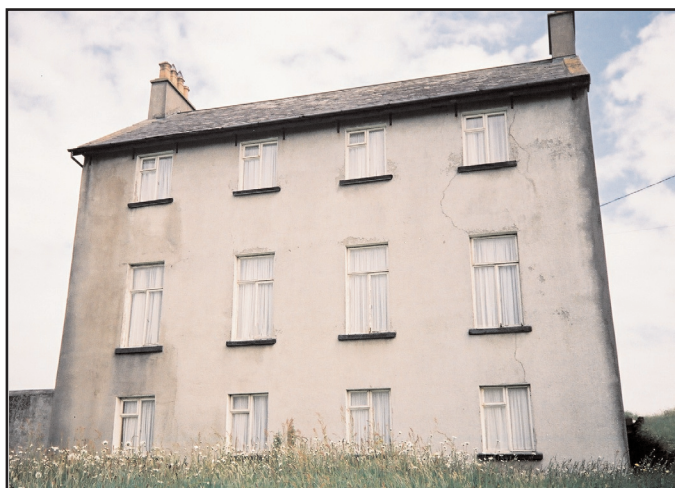
**Figure 2.** The mine manager's house.

Finally you come down to Knockmahon, where you pass the junction with the R681 Waterford road. Above a rock cutting on the left side of the road stands the fine 19th century three-storey house built for the mine managers (Figure 2). Across the stream on the other side of the road are the remains of the dressing floors where the copper was concentrated by a small army of men, women and boys (Figure 3). Today, the only substantial evidence of these dressing operations is the walled yard of the mine count-house on the slope above the valley floor, a cobbled dressing floor and a stone façade beside the course of the old mineral tramway.

In the reconstruction drawing, the mine manager's house, known locally as 'Petherick's House' after one of its occupants, is depicted just as it appears today (Figure 29; compare with Figure 2), but with an open-topped carriage waiting at the front door. The road that now runs alongside the stream below the house was constructed since the date of the drawing. From his elevated vantage point, the mine manager was kept aware of all the activity on the dressing floors across the valley, not least from the rhythmic din of noise that emanated from there day and night - from the background squelch of the waterwheels to the thump and rending of the stamps, as recorded in an 1840s report (Des Cowman, personal communication).

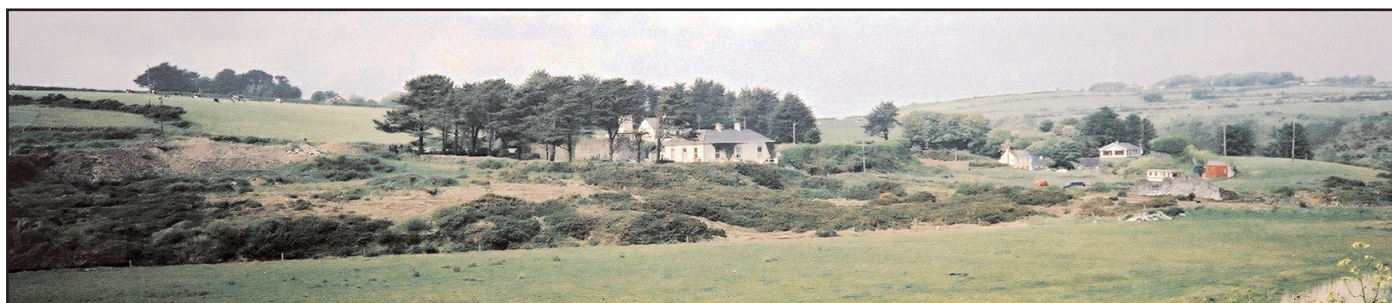
**Figure 3.** Dressing floors at Knockmahon, with the mine count-house at the centre.

The high-walled yard beside the road out of Knockmahon village, with the count-house at one corner, is the only substantial survivor of the 19th century dressing floors (Figure 20). The count-house, once the office for the day-to-day running of the mines, is occupied today as a private house (Figures 3, 12 and 20:A). The other buildings ranged about the yard walls are now roofless shells. Although it is not possible now to say exactly

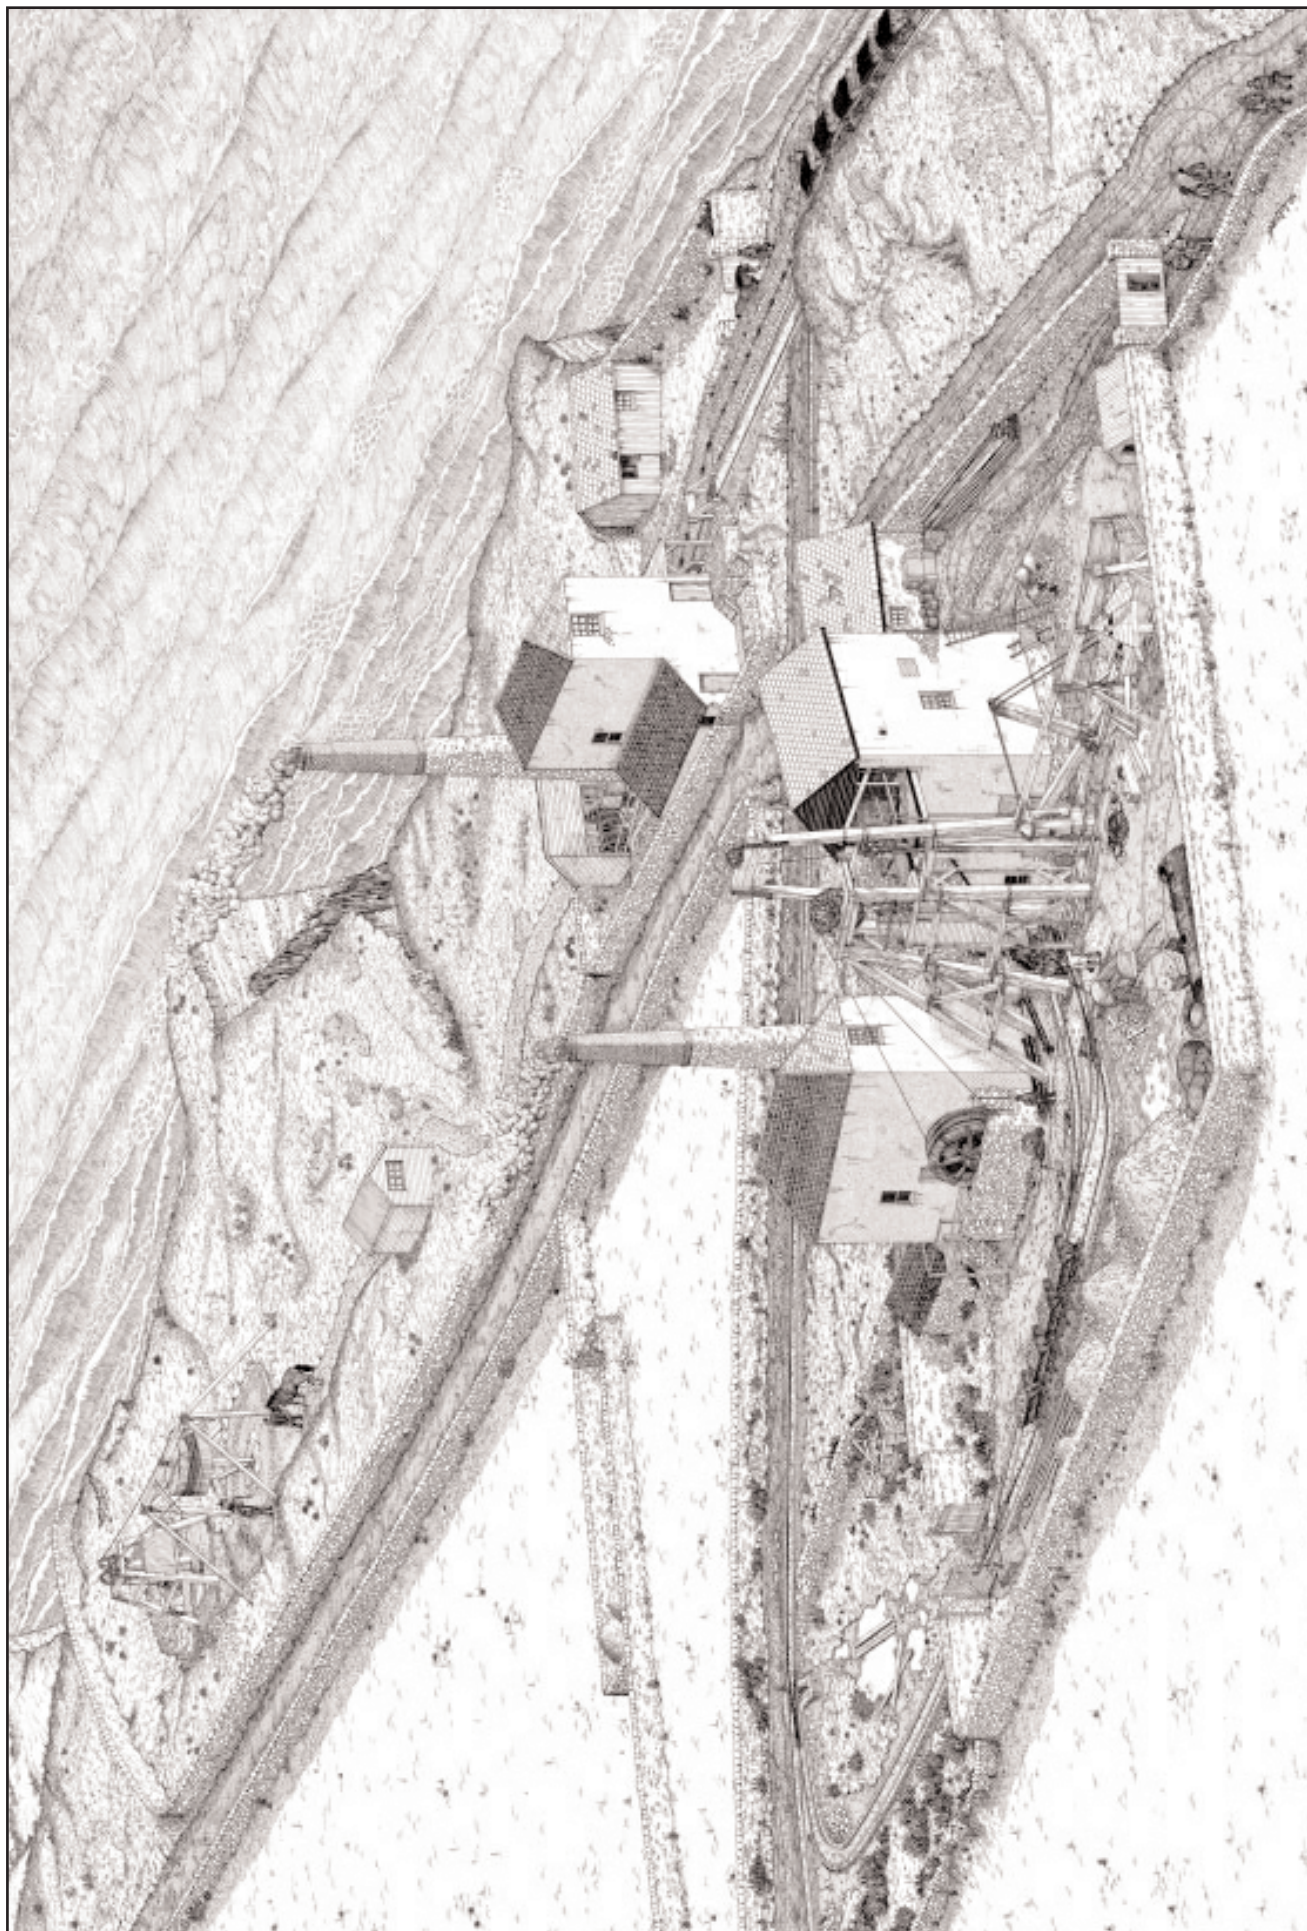
*Figure 6. The mines at Tankardstown as they might have appeared in about 1870. (© Daniel Tietzsch-Tyler, February 2006)*

The reconstruction drawing of the mines at Tankardstown attempts to show the complex of buildings and associated mining paraphernalia as they might have appeared in about 1870, just before ore production began to fall away irrevocably. Three main elements of the mine are illustrated in the drawing (Figure 14):

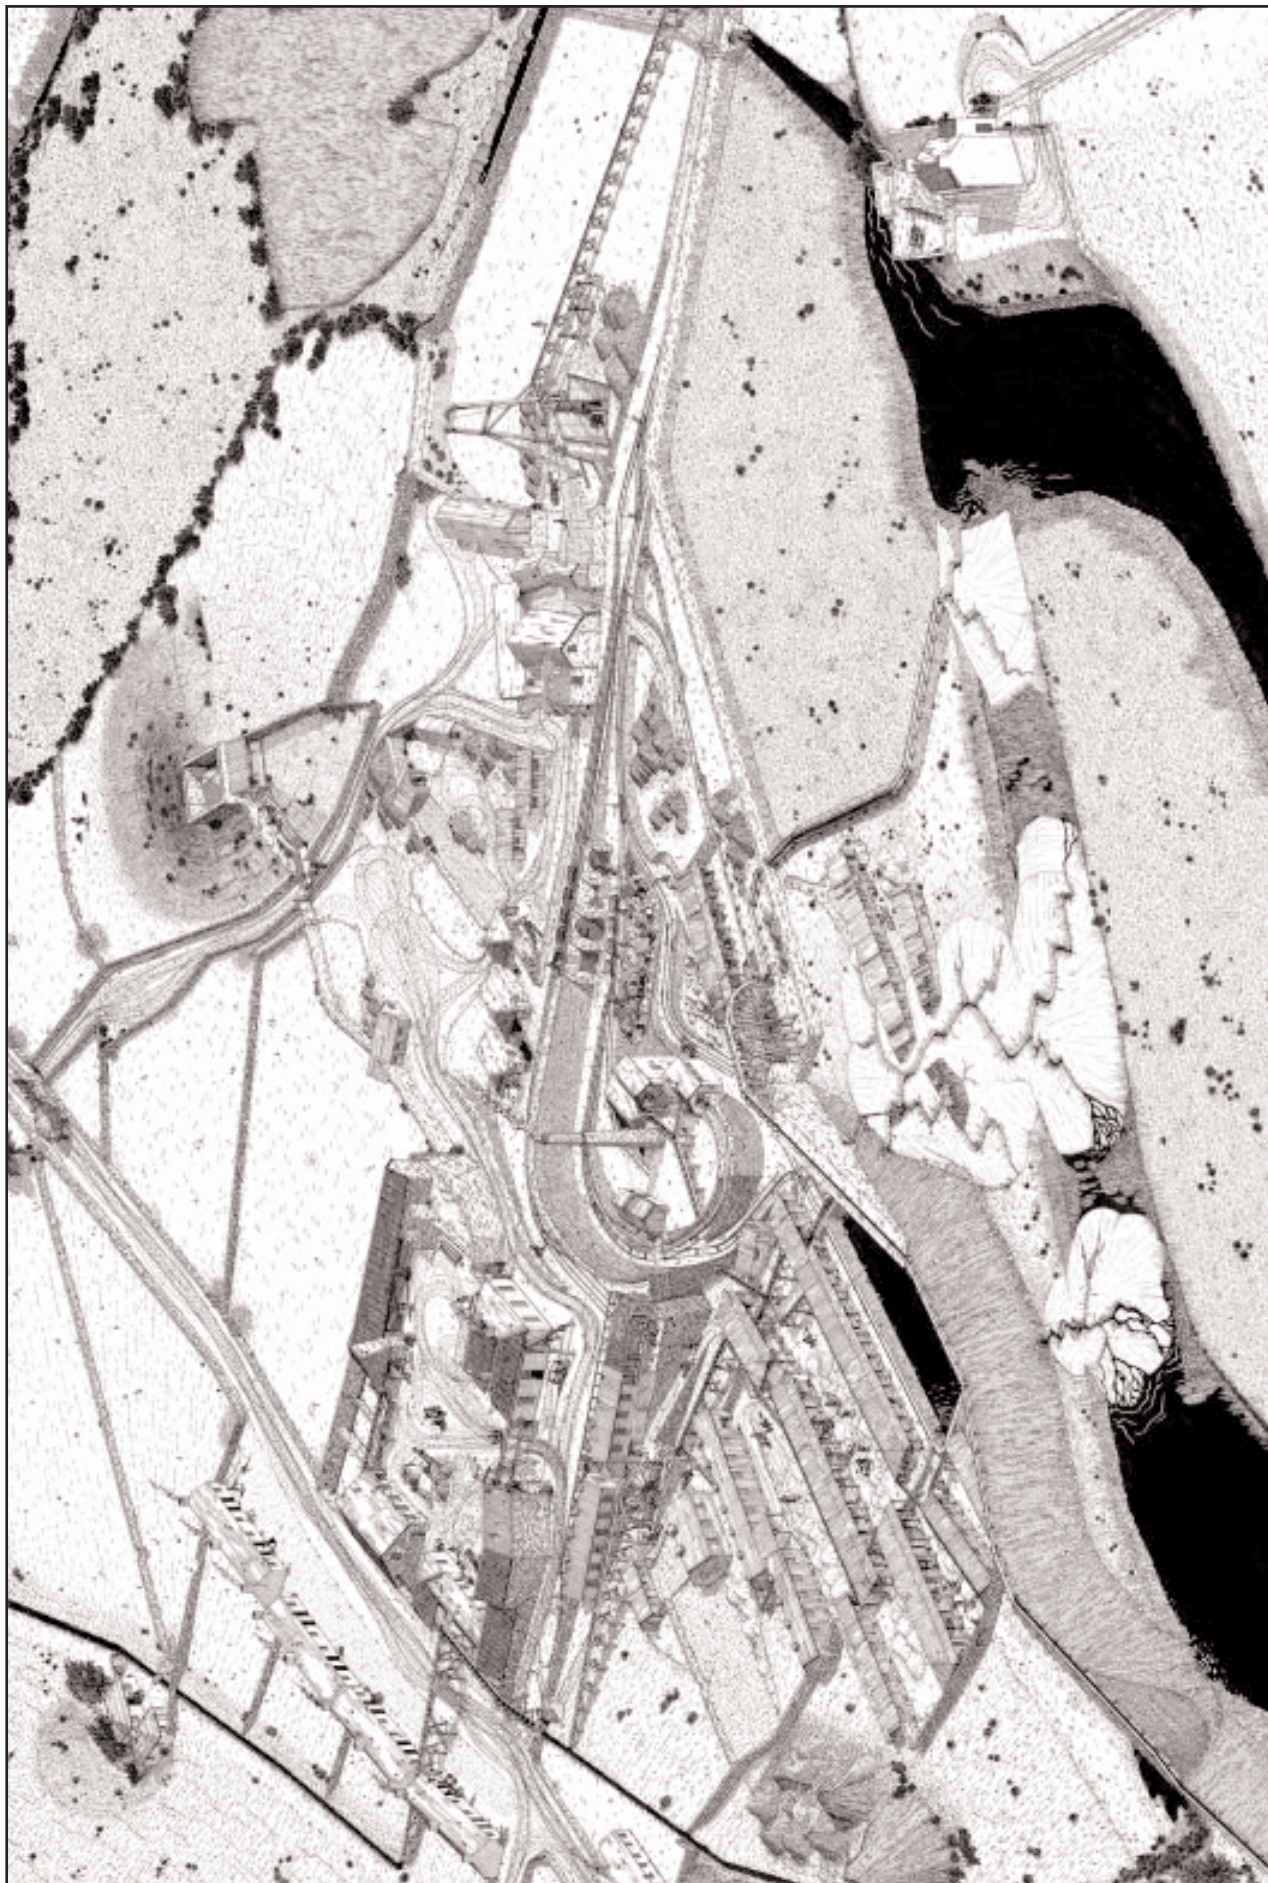
*Figure 7. The dressing floors beside Knockmahon village as they might have appeared in about 1860. (© Daniel Tietzsch-Tyler, February 2006)*

Because so little remains of what once stood on the dressing floors at Knockmahon, re-imagining the site depends to a great extent on mid-19th to early-20th century photographs of comparable mines in Cornwall (Trounsen and Bullen 1999). The second reconstruction drawing aims to bring back to life what is now virtually an empty valley. At the time represented in the drawing, about 1860, a large workforce of people of both sexes and all ages was employed here to dress the ore coming from the mines. A close look at the drawing will identify 93 people engaged in different activities across the area (Figure 19). The work was mostly carried out in sheds as shown on Smyth's mine map of 1845 (Figures 4 and 21). Most of these buildings would have been timber-built, but some were stone-built - we can either see the remains of some of the latter or infer stone-building from their functions (e.g. the engine and boiler-houses).

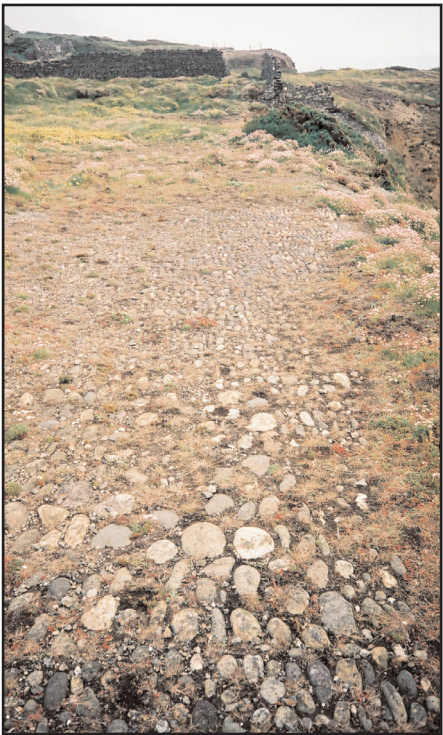
Figure 9. The cobbled copper yard.

The walled copper yard on the cliff-top above the cove is only one of several remains at Stage Cove. The copper yard itself was extended at some point after 1840 and consequently has evidence of cobbled surfaces at two different levels - that in the extended area being about a metre above that in the original yard (Figure 9). East of the copper yard, also on the seaward side of the road, are sections of wall and the shell of a small building corresponding to another ramp on the mineral tramway.

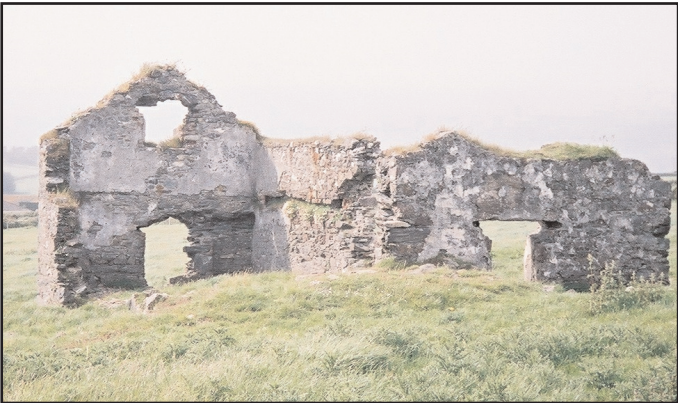
Figure 10. Ruined engine-house, Stage Cove.

Between the tramway and the cliff-top are several open shafts and the vague outlines on the ground of an engine-house complex that was dismantled when the mines here were abandoned in 1852. The ruins of one engine-house still stand on the landward side of the road (Figure 10). Two inclined grooves in the roadside wall of the tramway ramp probably accommodated support timbers for an elevated gantry that crossed over the road and tramway between the surviving engine-house on the landward side of the road and the shafts on the cliff-top. An 1845 drawing of installations at this location shows a horizontal winding cable system, supported on a gantry, connecting this engine-house and haulage gear over the cliff-top shaft (Figure 11). The tramway, constructed between 1854 and 1856 (Morris *et al.* 2005), passed below this gantry alongside the road.

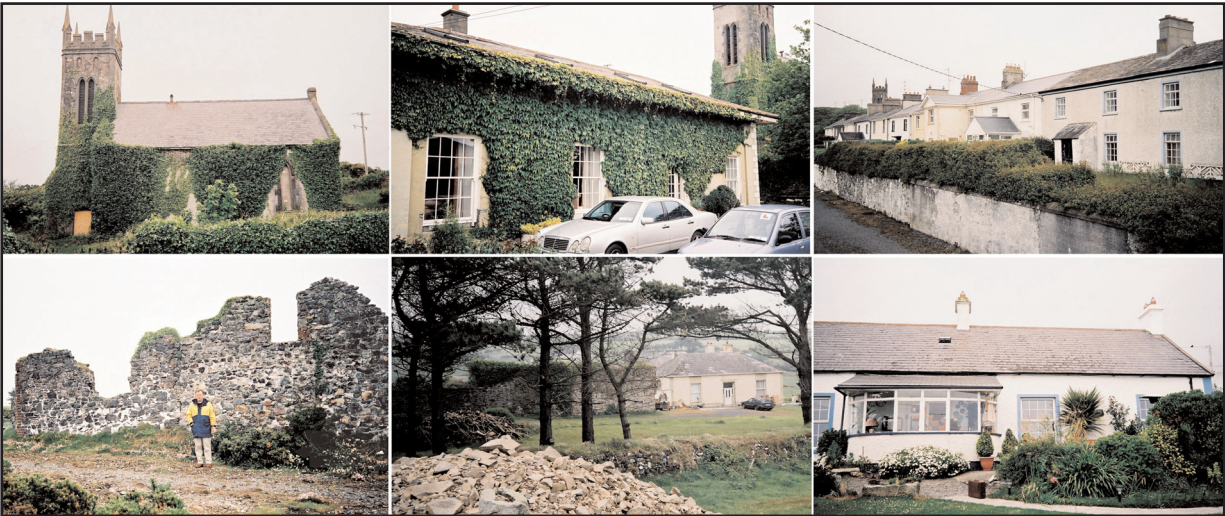
Figure 12. Below. Knockmahon village and dressing floors (clockwise from top left): the church; the school-house; Osborne Terrace; the company directors' house; the count-house and walled yard; the ruined facades of stone buildings on the valley floor.

The mine dressing floors were located beside Knockmahon village (Figure 4). The core of the 19th century village exists to this day, including the church (disused and ivy-covered), and the school-house, the mine management's houses of Osborne Terrace and the house built to lodge the MCI Director(s) - all still occupied to this day (Figure 12). Terraced miners' cottages shown alongside the road out of the village on 19th century maps have long been demolished and part of that area has been re-developed as the National School (Figures 19:G and 21).

of the mineral tramway - still clearly visible (Figures 12 and 13:G) - and the foundation for a stone building is also preserved in the wall of a small, more modern quarry beneath the count-house yard (Figure 13: F).

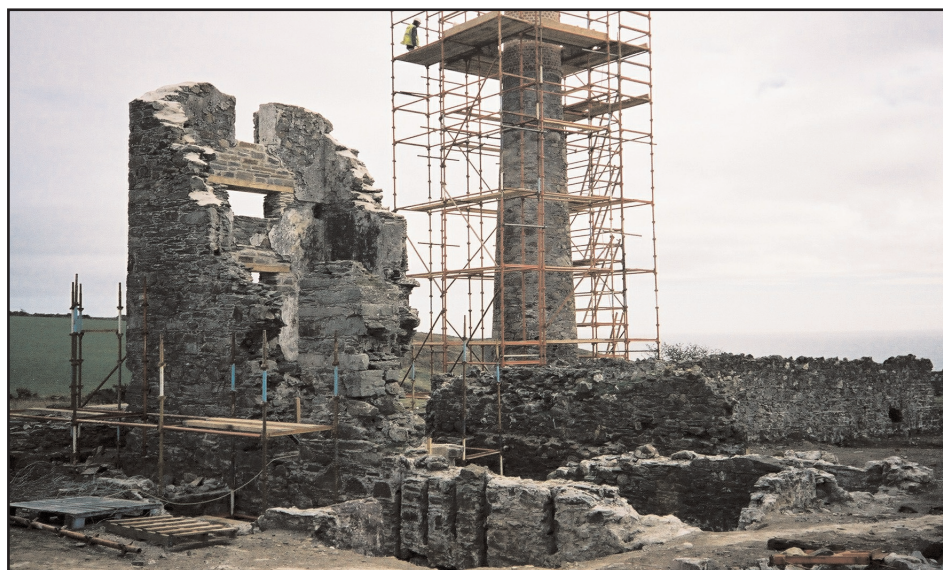
**Figure 16.** *The winding engine-house at Tankardstown. The vertical grooves in the wall in the foreground are for the long retaining bolts that secured the winding drum. The higher wall between the engine-house and the chimney beyond it is the long wall of the adjoining boiler-house.*

One end wall of the winding engine-house (Figure 15:K) still stands close to its full height (Figure 16). Only the lower levels of the rest of the building's walls remain. Vertical grooves for the long bolts that secured the timber mounting for the winding drum can be seen in the outer face of one wall (Figure 16). Most of the long wall of the lean-to boiler-house (Figure 15:L) also

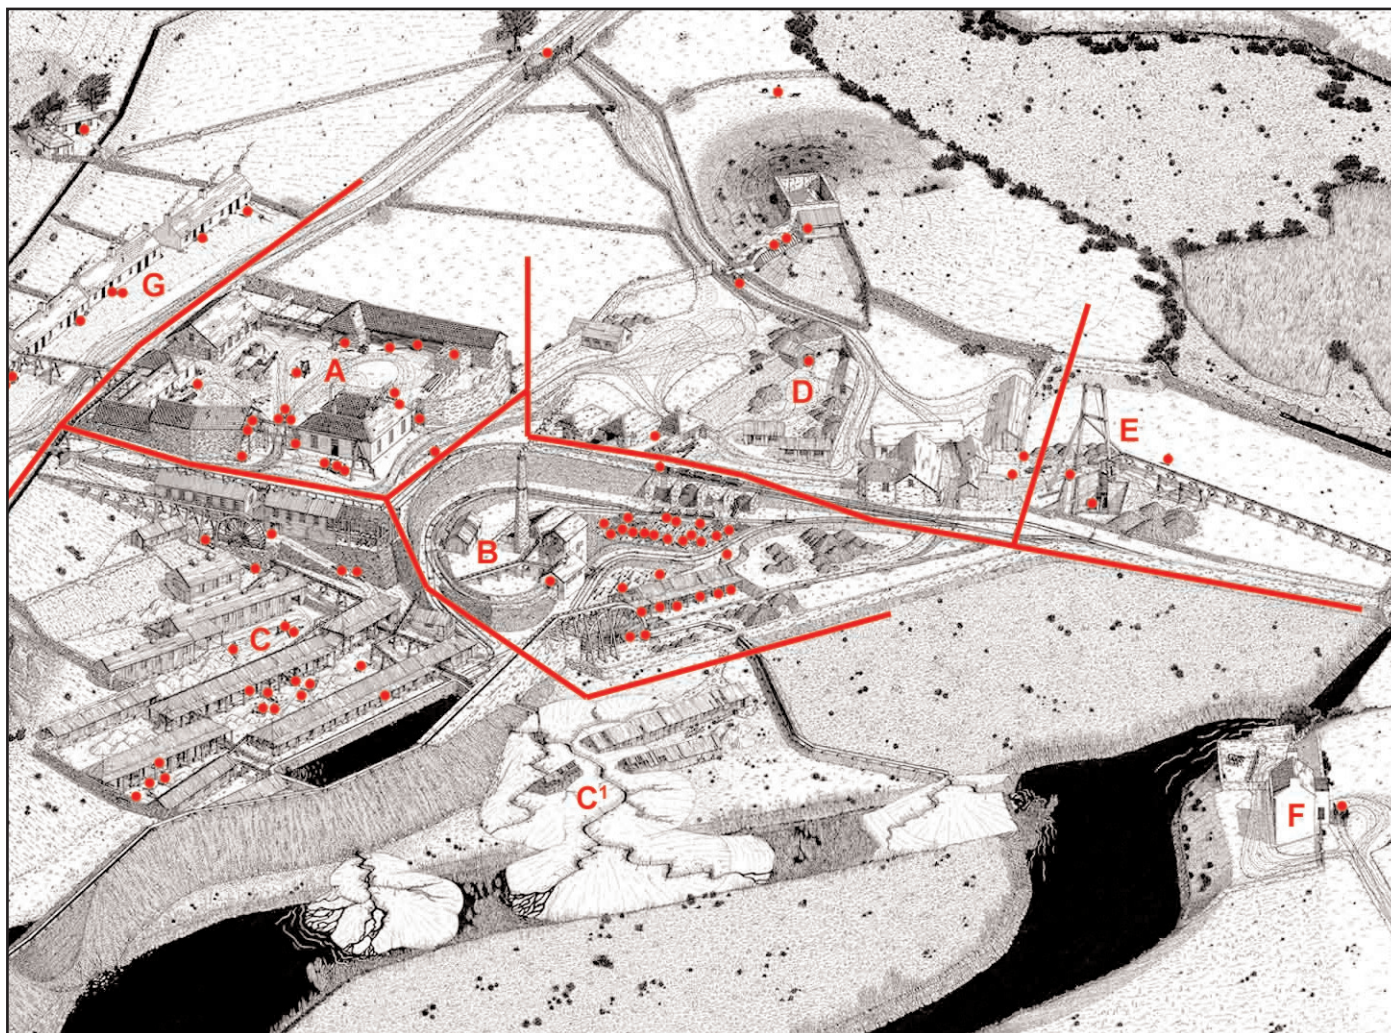
*Figure 19. The ore dressing floors at Knockmahon as they might have appeared in about 1860: count-house yard (A); breaking, crushing and jiggling area, including engine-house and boiler-house (B); main dressing floor (C) including several sheds housing circular buddles (some sheds are shown ruined and disused on the valley floor, partially covered with mine waste: C1); gunpowder overlooking yards and sheds on different levels (D); Downright Shaft (E); mine manager's house (F); miners' cottages (G and G1). The red spots mark the locations of all the 93 people included in the reconstruction drawing.*

In the following discussion, the dressing floors are divided into five areas (Figure 19):

- the count-house yard (Figure 19:A)

- the breaking, crushing and jiggling area (Figure 19:B)
- the main dressing floor, where the ore was concentrated (Figure 19:C)
- the gunpowder magazine, and the yards and sheds it overlooks (Figure 19:D)
- Downright (or Engine) Shaft (Figure 19:E)

The reconstruction drawing also shows the mine manager's house (Figure 19:F) - which, together with the count-house, provides a present-day anchor point for locating the other elements of the site - and former terraced miners' cottages beside the road from Knockmahon village (Figure 19:G).

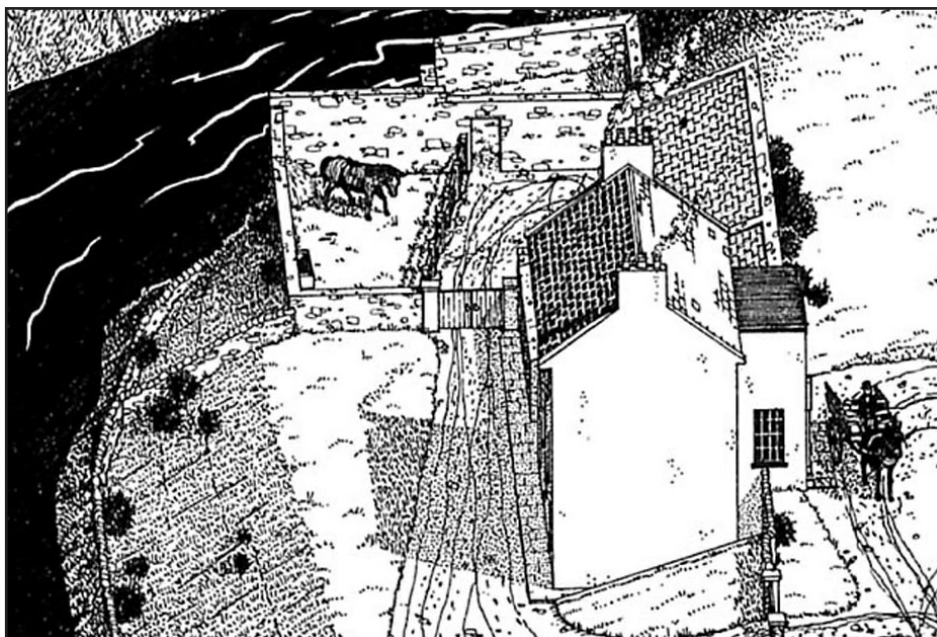
**Figure 29.** The mine manager's house stood above the river with no road between them in the mid-19th century.

Presumably the mine manager was able to access the complex either via a combined tramway and access bridge over the stream, as shown near the extreme left hand edge of Figures 7 and 19, or by travelling the short loop of road inland that crossed the stream north of the magazine and past the front of the count-house yard on its way into Knockmahon village.
