IN SEARCH OF HODGSON'S TRAMWAY

Ewan Duffy

Abstract: This deals with the practicalities (and difficulties!) of tracing the scant remains of Hodgson's tramway. *Journal of the Mining Heritage Trust of Ireland*, **3**, 2003, 21-24.

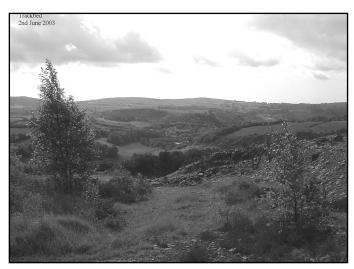
Immediately north of the arch, it is possible to make out what I believe to have been the trackbed. The difficulty facing me, as someone who has been identifying sections of trackbed for over 10 years, is that the angle of the pathway is not in line with the arch and therefore, a sharp curve would have been required coming off the arch. However, it should be remembered that tramways can have sharper curves than conventional railways.

Figure 3. The trackbed at Ballygahan.

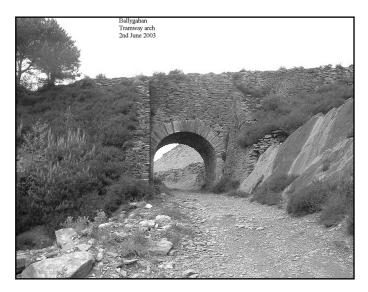
At Ballygahan, I found two rails which may have been in use as part of the tramway, being approximately 3'6" apart. The tramway passed over the tramway arch and therefore, I started my search proper just above it, one of the best remaining engineering features of the line.

Figure 4. The tramway arch at Ballygahan.

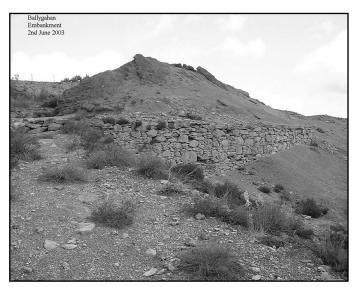
South of the arch, the embankment can be made out and although heavily overgrown with trees and gorse, can be followed for a short distance. From the arch itself, views over the surrounding landscape, including the mining area of Tigroney can be seen.

The embankment continues for some 200-300m, before drop-

Figure 6. The embankment for the tramway at Ballygahan.

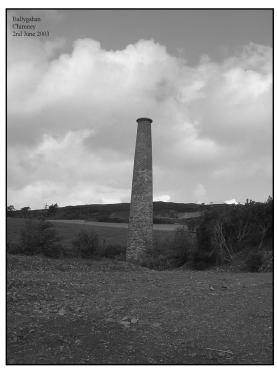
ping to the level of the adjacent "Red Road". Beside the trackbed at this point, there remains a chimney and about 200m away, the remains of an engine house and another chimney, the former retaining an attractive brick arch. Murray stated that the

Figure 7. The engine house chimney at Ballygahan.

house that contained the winding engine to raise the wagons up the line was about half way up the inclined plane. The former would appear to be all that remains of this feature.

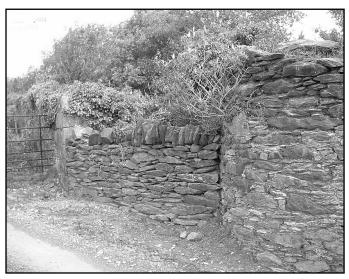
From here, the road parts company with the tramway and it is difficult to pick out where it ran. There is no obvious sign of anything that looks like a tramway alignment, until you deviate away from the main road and turn up a private access road to a farm. On the right hand side of this, there is what looks like a filled-in gateway which leads into the undergrowth. It is at this point that errors could easily be made as I presumed that this was a filled-in crossing on the tramway. Ken Brown set me straight in his paper by correctly identifying it as the remains of another engine house. Such are the hazards of survey work. The modern road takes a hairpin approach down the hillside

Figure 9. The gateway / engine house remains.

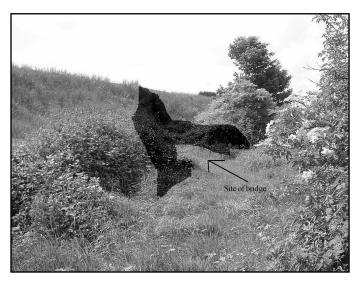
with no evidence remaining of the tramway. It is likely that this took a more direct approach. The marshalling yard was at the foot of the hill on the southern side of the road with the tramway following a route back towards the main road to Avoca. There evidence of the tramway can be found again in the shape of an embankment.

Figure 10. The location of Ballyraine underbridge (high-lighted). The arch has been filled in but stonework through the vegetation reveals its position.

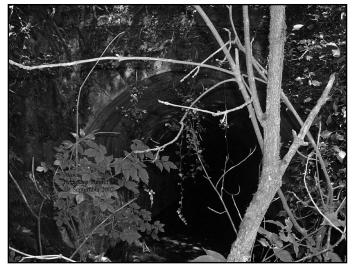
The road into Avoca was raised, the river diverted south of the present road bridge to avoid the need for two river crossings and a new tunnel constructed under the road for the tramway, which remains to this day. Thus a new line of tramway was created. For a period, the tramway from Avoca to Ballyraine was locomotive worked, but from there to Arklow and from the mines to Avoca was horse worked.

Figure 11. The tunnel mouth.

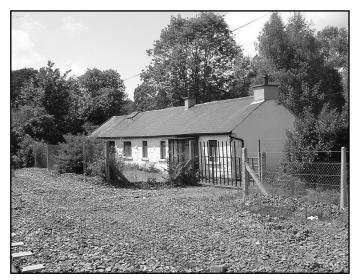
Figure 12. The white cottage, a former smthy for shoeing tramway horses.
