SALVAGING MINESITES - THE CASE OF KEEL

Phelim Lally

Abstract: The objective of mine heritage enthusiasts, when presented with abandoned mine sites, is ideally to develop a full documentary record of the locale, and at the same time to preserve as much of the physical remains as is possible. Happily, such a degree of preservation was made possible in July of this year at Keel minesite, Co. Longford. *Journal of the Mining Heritage Trust of Ireland, 2, 2002, 3-7.*

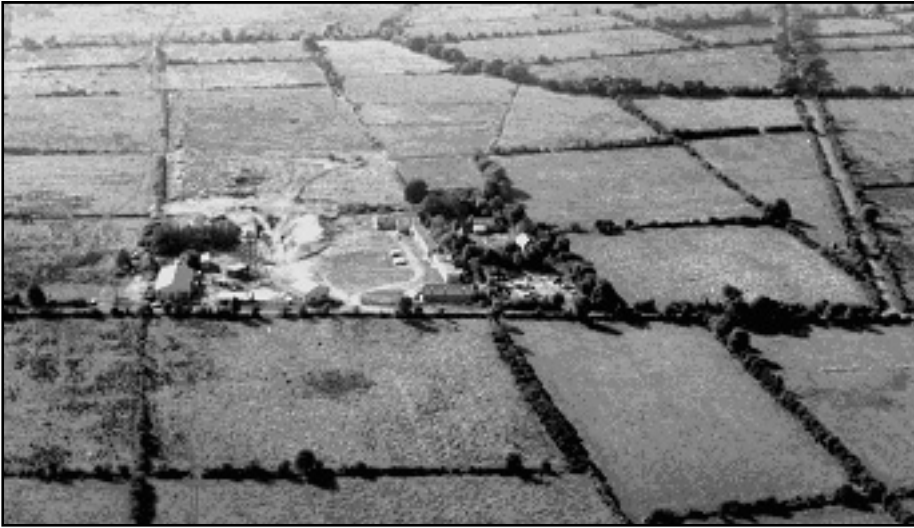
Figure 2. Aerial view of working mine, 1960's.

Keel (Figures. 1,2) was never a working mine. It was rather an exploratory shaft sunk in the mid-1960's to determine the economic extent of zinc mineralization in a fracture system developed here in the lowermost strata of the rock sequence known geologically as the Carboniferous System. Having said that, it was nevertheless pretty unique in Ireland, in that both the shaft and the underground workings, as well as the surface structures, were substantial.

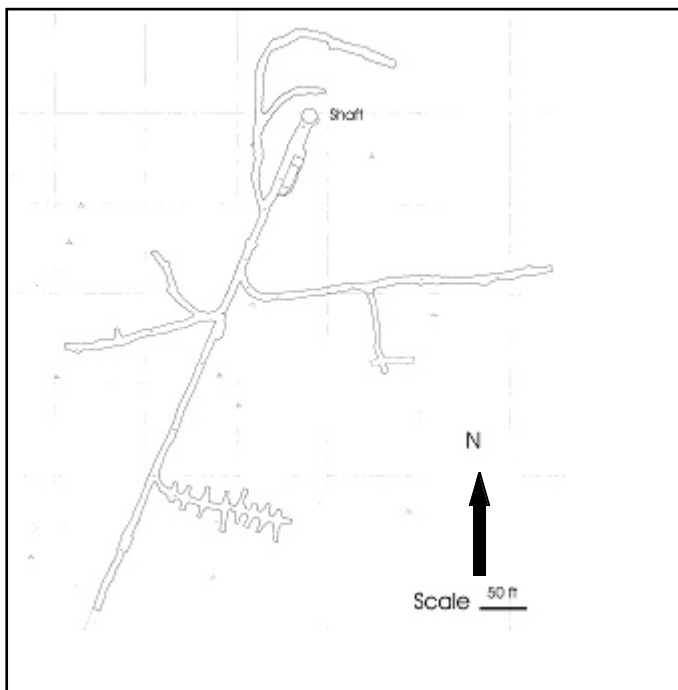
Figure 3. Example of underground development at Keel: Plan of the 500 Level.

The shaft is a concrete-lined 16ft-diameter circular shaft, sunk to 585 feet, and from it development took place on three levels: 200ft, 400ft, and 500ft below surface (Fig. 3).

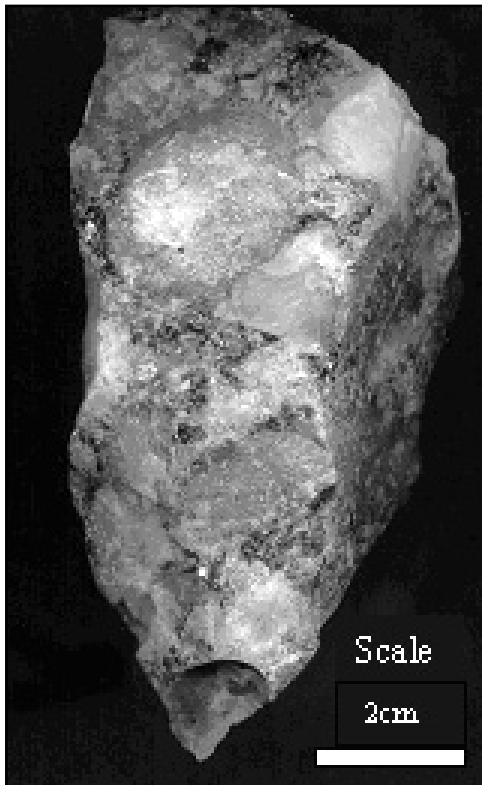
Figure 4. Keel ore showing zinc-blende (ZnS, sphalerite) as the darker patches, in the interstices of a pebble conglomerate.

of reserves came to a mere 1.85 million tons, though grading reasonably well at 7.71% Zinc. There was lesser lead, cadmium and silver. The mineralization varies in style, but perhaps the prettiest textures are seen where honey-coloured zinc-blende (sphalerite) has been deposited in the matrix between rounded beach pebbles of quartz and sandstone of different hues. One is in fact looking at a fossilized version of a shingle such as occurs along the beaches of Wicklow at Greystones or Bray! (Figure 4)

The recovery of mineral specimens (see Figure 4) was made possible by pinpointing two spots - one adjoining the drillcore sheds and the other among the spoil heaps - where quartz breccia showing good sphalerite but of low overall zinc grade had been dumped. Specimens collected were brought back to the GSI.

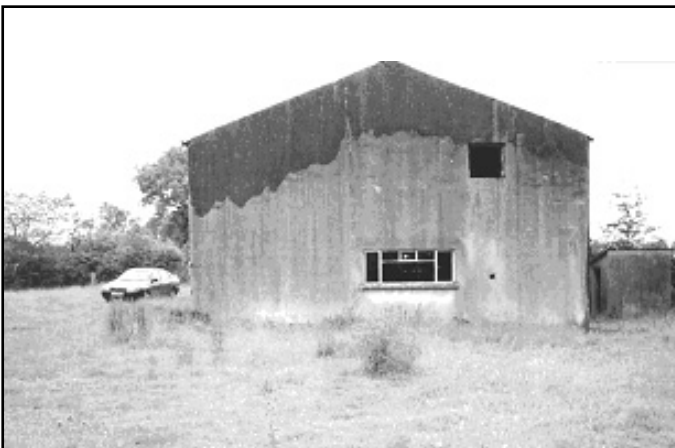
Figure 7. View of former hoist house. Opening at upper right of wall allowed for passage of pulley cables to head-frame.

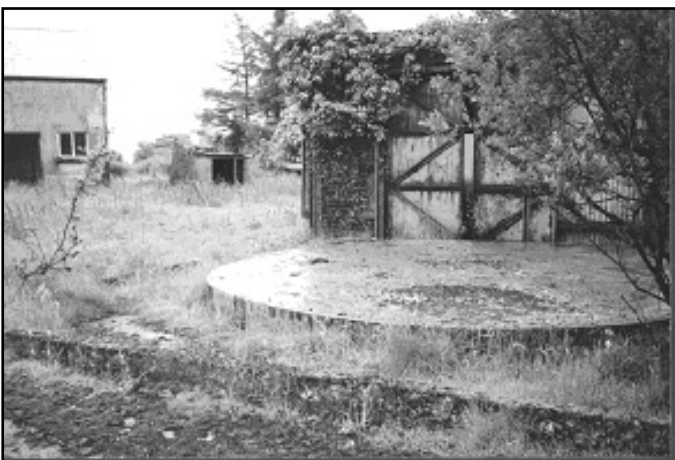
Figure 8. View of circular shaft, capped with concrete in 1988. Behind is the shaft signalling and access shed, and to the left, part of the electrical-mechanical workshop.

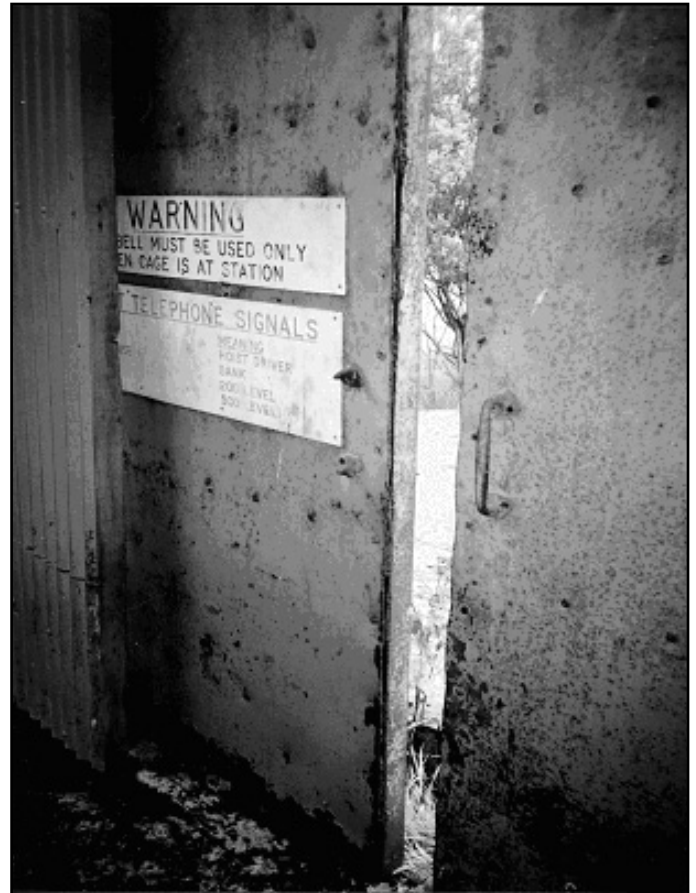
Recovery of articles of mine heritage value from the site consisted of unscrewing of signalling and other signs from inside the shaft access shed (two of which are shown in Fig. 9); the removal of a manufacturer's plate from a ventilation fan housing which lay outside the shaft buildings; and the transfer of the door of the cage occupied by the mine personnel to go underground.

Figure 9. Mine safety and signalling signs inside former shaft access shed.

The signs have been cleaned and are lodged in storerooms at the Geological Survey. The plate of the ventilation fan, an

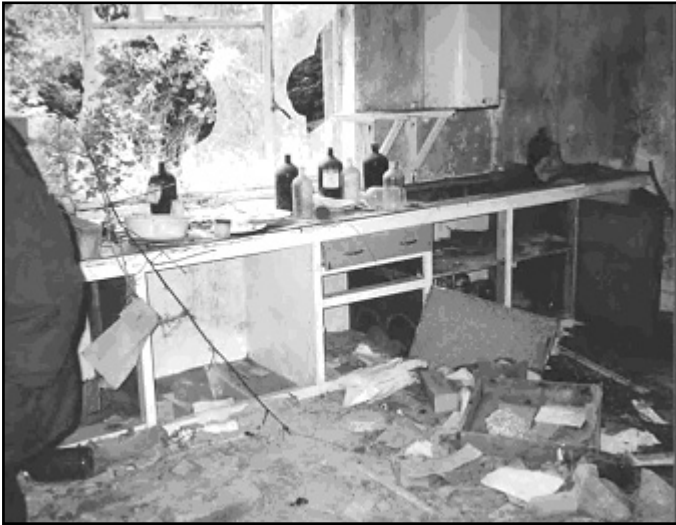
Figure 10. Interior of former Wet Lab.

A fuller report on the state of the buildings and spoil heaps can hopefully be carried out in the context of future engineering or waste management work at the site. This year, for example, an evaluation of the spoil may be feasible as part of a mine waste survey for Ireland being completed by staff of the GSI Minerals Programme. It was noted that while the buildings are all still standing and possible to enter, any remaining items of furniture or utensils are broken and in disarray (see Figure 10 for example).

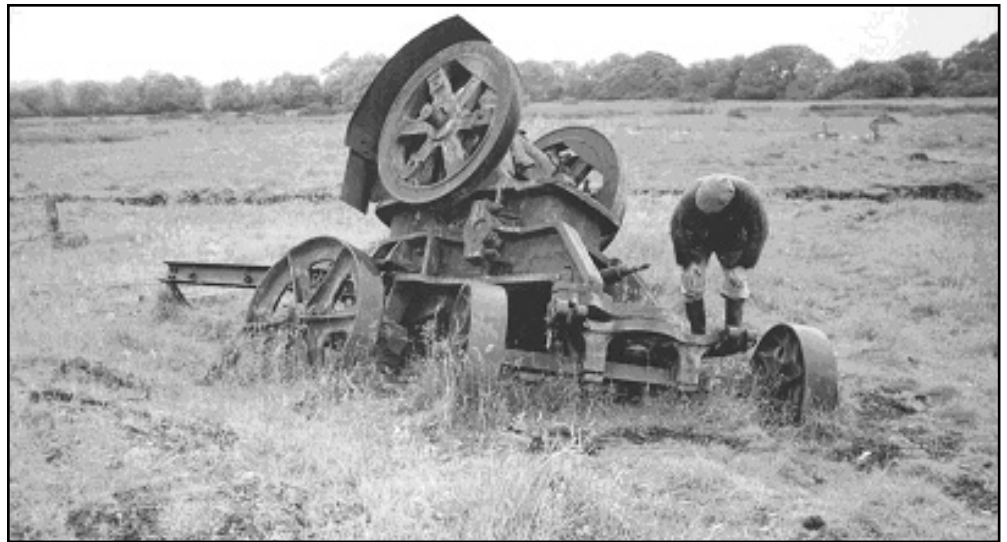
The one artefact that has proved impossible to recover is a portable jaw crusher of some size, now languishing on the bog that adjoins the mine site to the west (Fig. 11). This intriguing piece of machinery, made of iron and weighing many tons,

appears to have been at work where a ventilation - and possibly extraction - raise came to surface from the 200 Level at the western extremity of the underground workings. It now lies partly sunk into the raise opening. Besides meriting study by mechanically-minded members of the mining heritage fraternity as to its method of operation, perhaps the most noteworthy aspect of the machine is its having been made up on site, as you

would an model airplane kit. This is evidenced by the part numbers in large emboss which can be readily seen on the different members of the chassis and moveable sections.

Figure 11. Portable crusher at western extremity of site.

Sadly, short of using a crane, there is no possibility of removing such a heavy object to a site where it might be put on display. Lifting it indeed might provoke the sundering apart of the pieces of the "kit".
