THE LISHEEN MINE CO. TIPPERARY: PLANNING A WORLD CLASS CLOSURE

Brendan Morris

Abstract: Production at the Lisheen Mine, situated in the heart of the Irish Midlands, ceased in December 2015 after 16 years of production due to depletion of ore reserves. The closure process, which will take several years, was planned well in advance and proper provisions were put in place to ensure that the mine, surface infrastructure and the environment is properly managed and in compliance with statutory and regulatory requirements well into the future. This descriptive paper outlines the closure process and provides a visual record of the rehabilitation of the tailings management facility. *Journal of the Mining Heritage Trust of Ireland* **15**, 2015, 93-103.

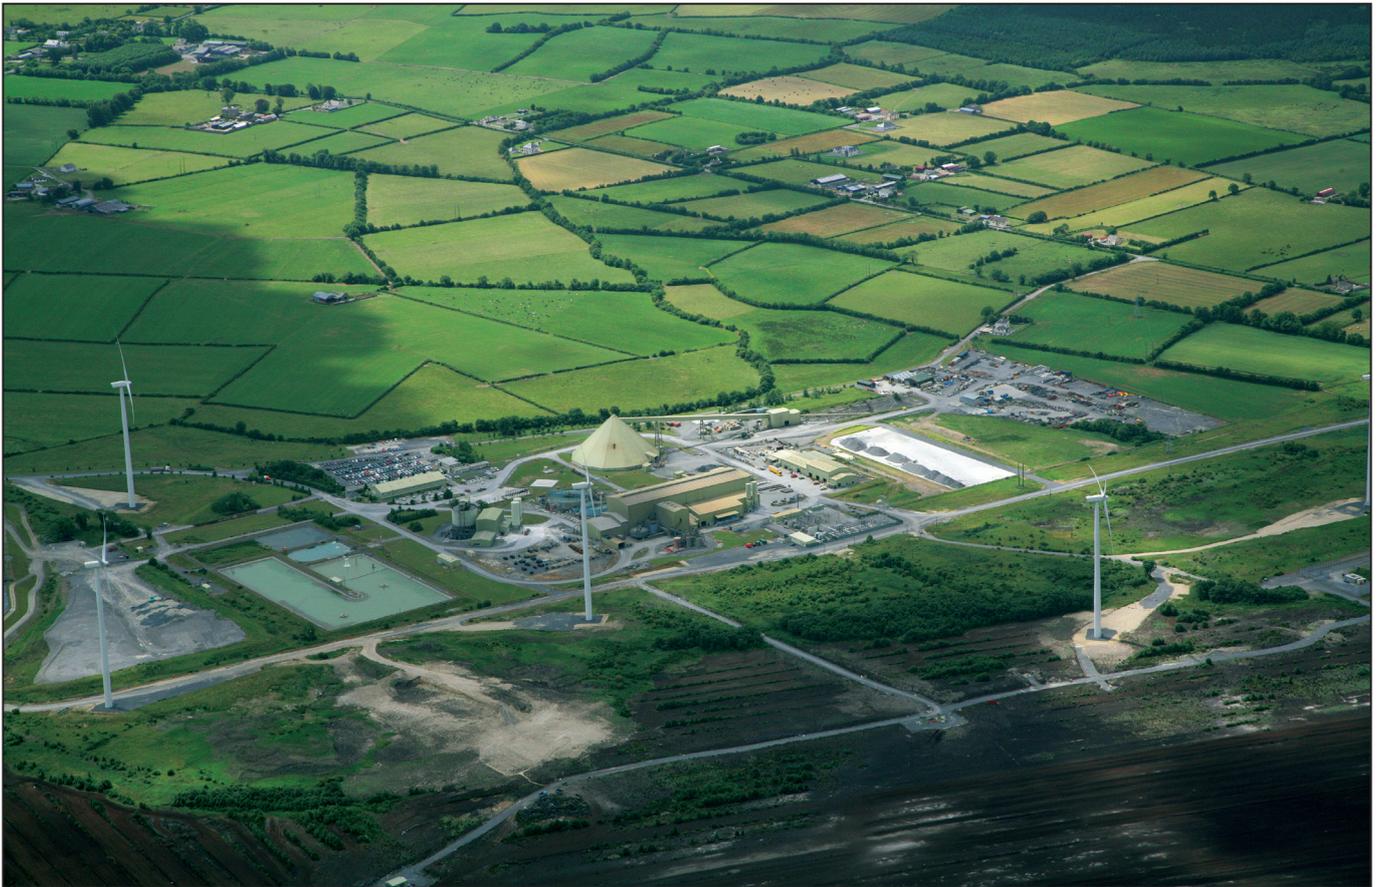
Fig. 1: The Lisheen Mine site, July 2010

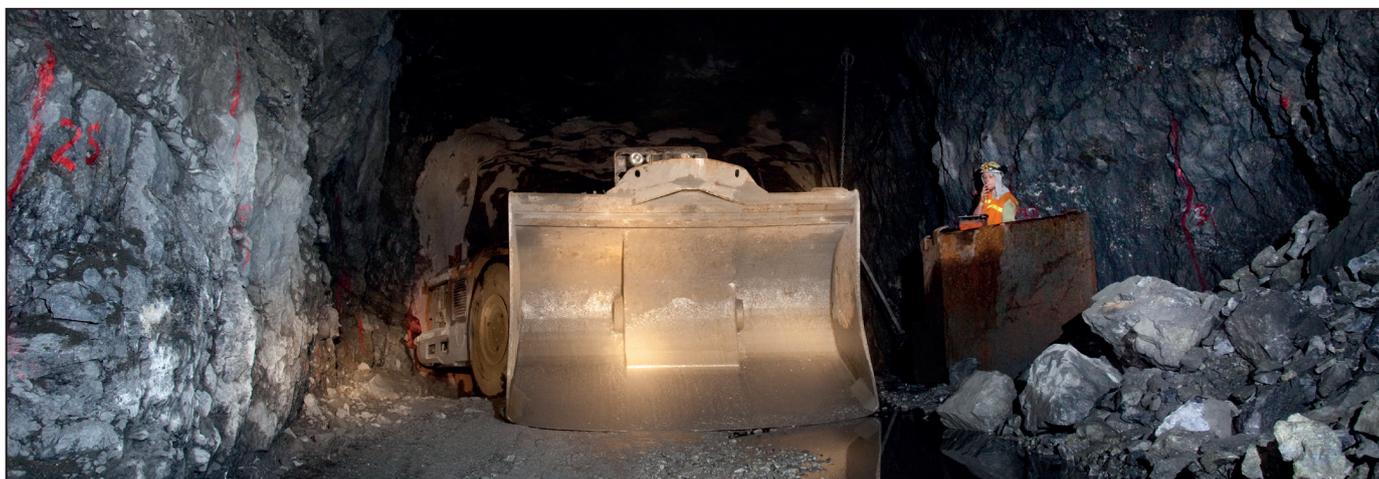
Fig. 3: Load Haul Dump machine in operation on remote control

Ore was produced from the development cycle (tunnelling within the orebody) and the production cycle (massive ore mining) within the mine. The ore was drilled using a variety of large drilling machines and then blasted using an ammonium nitrate based emulsion explosive combined with non-electric detonators. Using Load-Haul-Dump (LHD) machines, the ore was then loaded onto 40 and 50 tonne trucks for transportation to the underground crusher, where it was crushed to <150mm

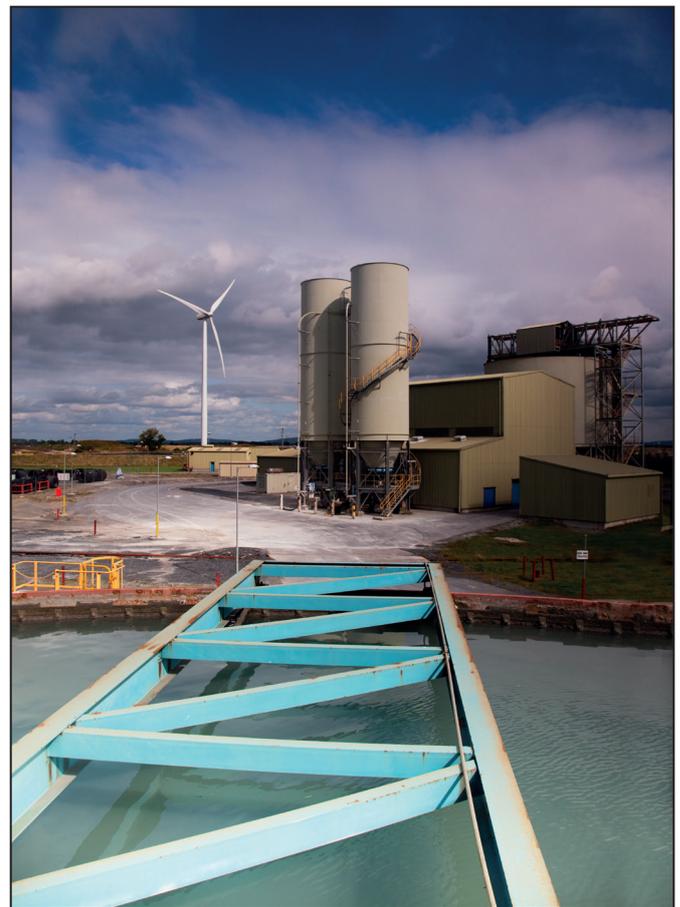
Fig. 4: Backfill Plant

A system of backfill was used at Lisheen to fill voids which were made as a result of the extraction of ore from mining areas. Backfill was also used to provide the necessary strength fill material to facilitate extraction of secondary and tertiary mining areas. Backfill also provided support to the overlying strata in order to prevent surface subsidence.

When a section was mined, the area was sealed and backfill pumped in a liquid state to fill the void. Backfill at Lisheen was made from the tailings (finely crushed rock with the economical metal removed), which was produced at the concentrator. The tailings was then mixed with a binder, Ground Granulated Blasting Slag and Ordinary Portland Cement. The backfill then hardened over a period of 28 days to a strength of approximately 500kPa, and at this stage the adjacent secondary or tertiary mining areas were available for mining. The concentrator produced more than 1Mt of tailings per annum and approximately 43 % of the tailings material from the concentrator was pumped underground as backfill.

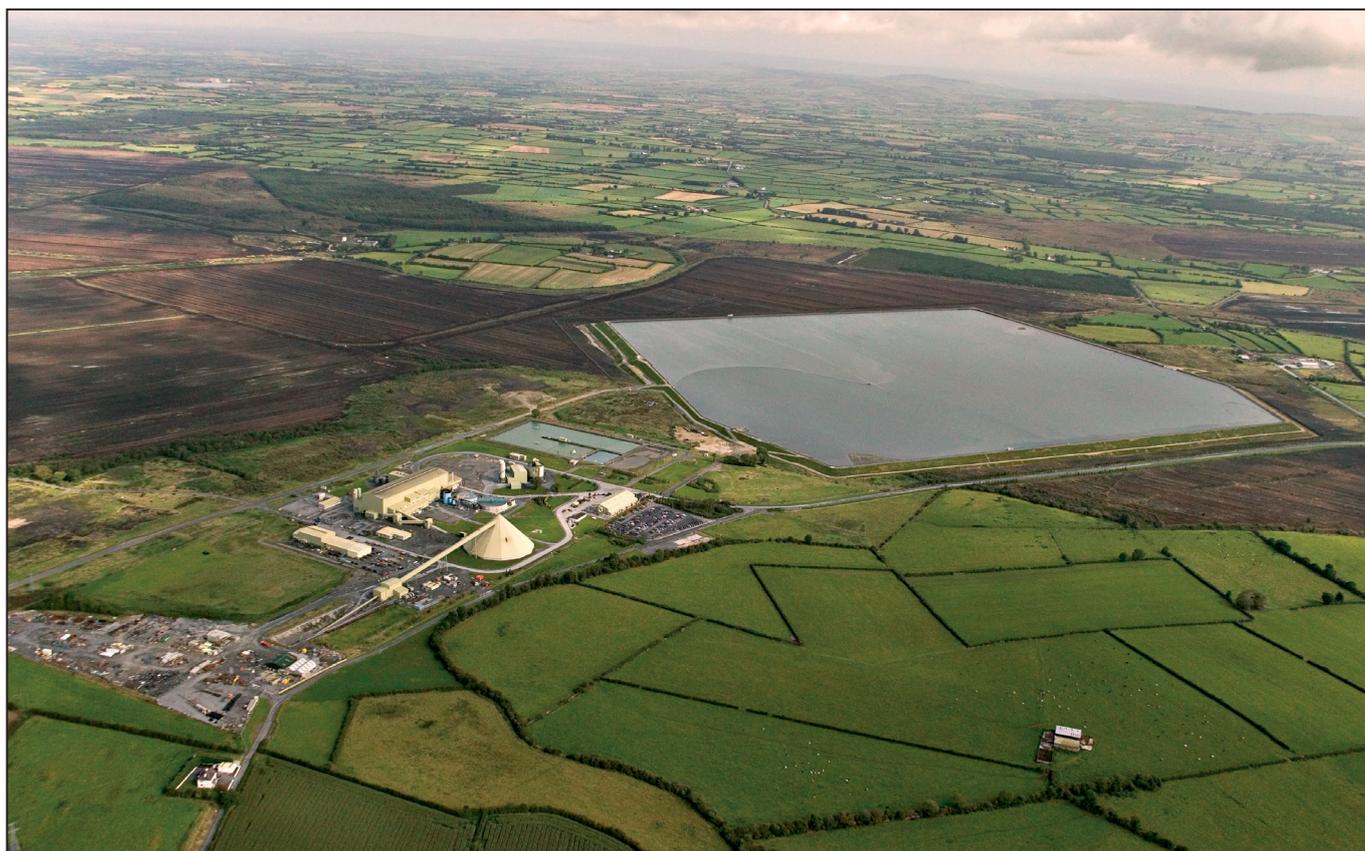
Fig. 6: Lisheen Mine prior to rehabilitation. Note the tepee centre left and large tailings management facility in normal use which the company has planned to rehabilitate in line with strict environmental controls after closure

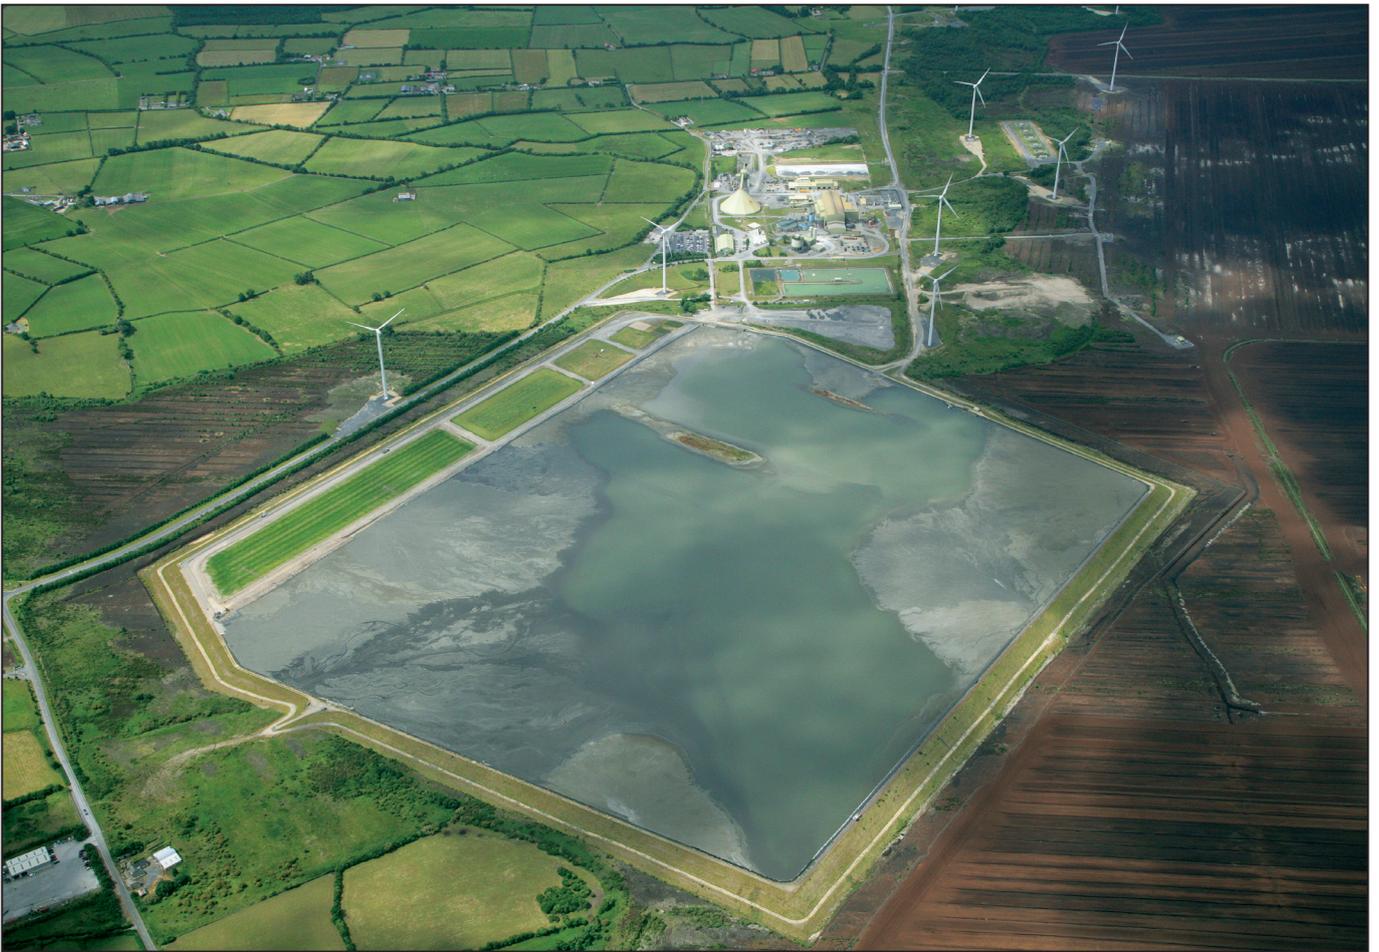
Fig. 7: First phase rehabilitation. Image, Peter Barrow 2010

A major part of site closure and rehabilitation is the Tailings Management Facility (TMF). A phased process of closure was started in 2011 when a part of the TMF was rehabilitated by covering the tailings surface with a geotextile layer, followed by capping with rock and topsoil and then grassing. Cattle were reared on the rehabilitated TMF under a strict testing regime to ensure that there was no contamination from the tailings material. The TMF rehabilitation has undergone several phases, with the final phase expected to be completed in 2016. Further environmental testing will continue for several years to ensure that the highest standard is maintained.

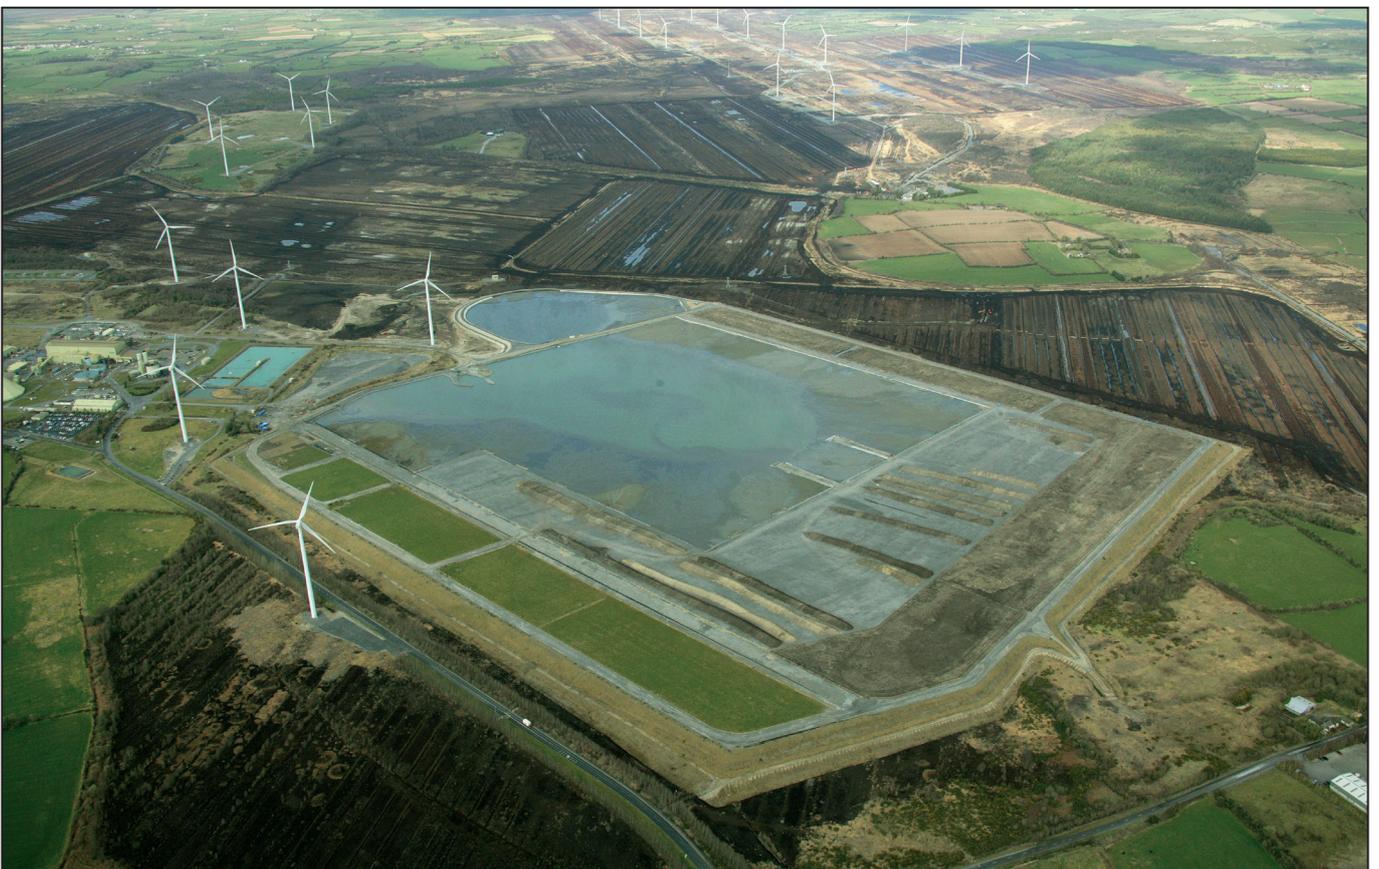
Fig. 8: Second phase rehabilitation. Image, Peter Barrow 2015

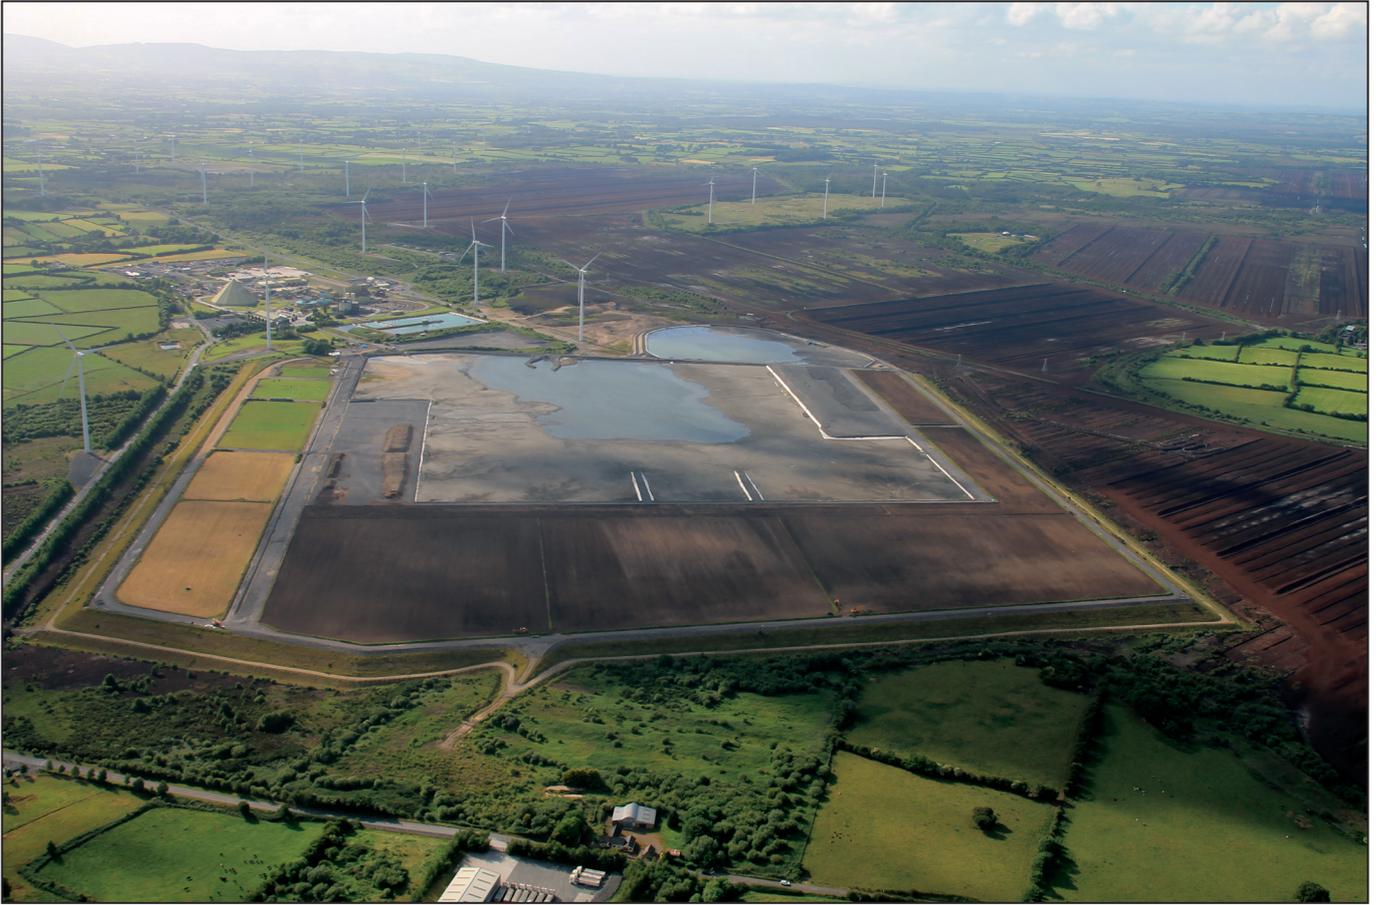
Fig. 9: Third phase rehabilitation

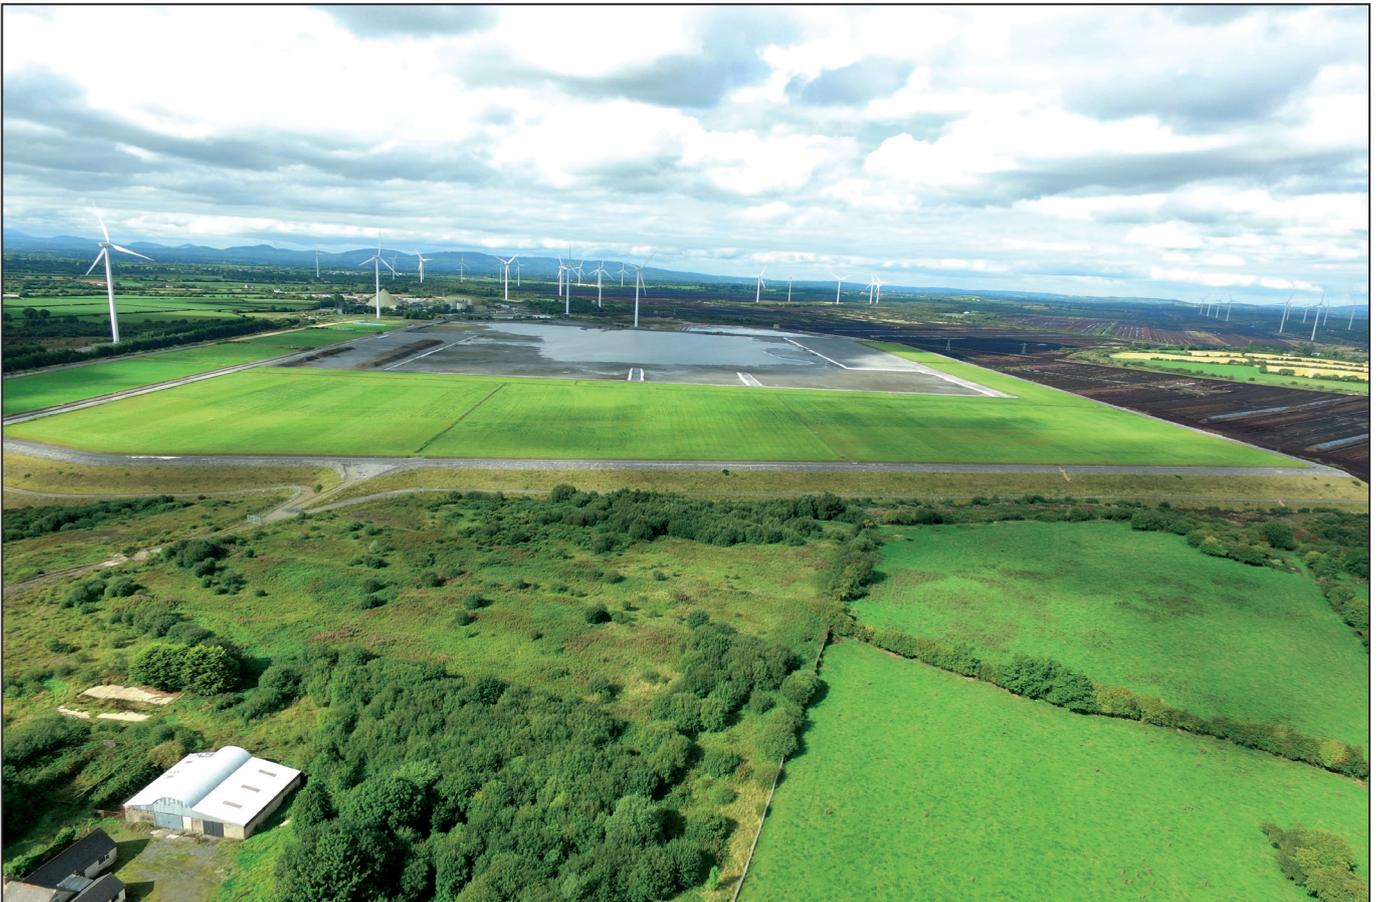
Fig. 10: Fourth phase rehabilitation

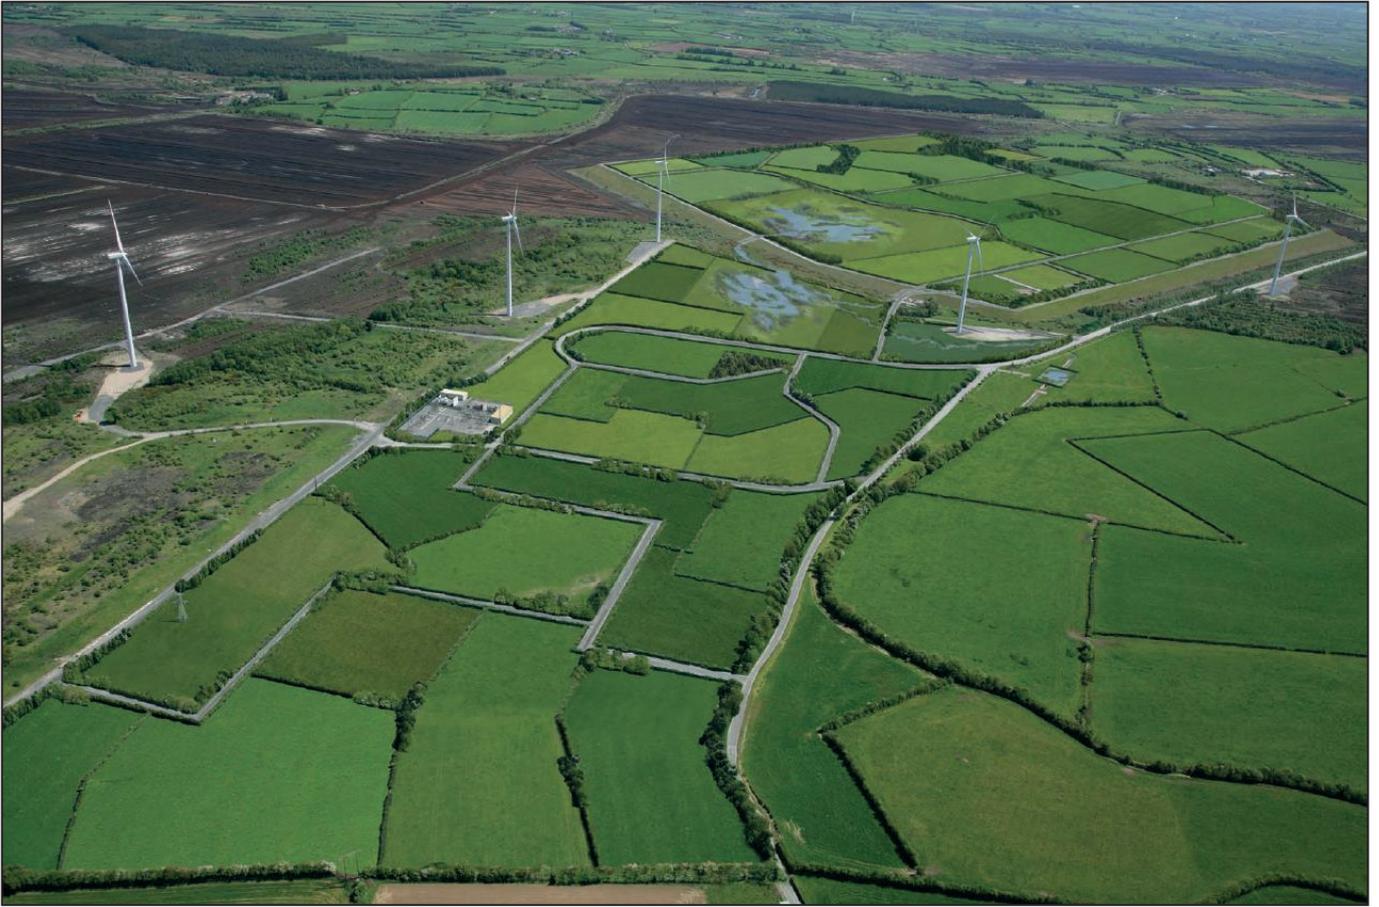
Fig. 11: Original Plan for Post Closure Site Rehabilitation

The original plan for the full site if no other use is found, was for the wind farm to be retained on the site post closure, and all other surface buildings to be demolished. This may now change based on the new site status and the potential for use as a Bio Energy Hub.
