# THE MINES OF BARAVORE, GLENMALURE, CO. WICKLOW

Stuart Chester & Nigel Burns

**Abstract:** The extant remains from 19th century mining at Baravore, in Glenmalure, County Wicklow are described. Six adits are connected by a miner's road. Two crusher houses are present, the older one with a water wheel pit. A series of leats, diverting water from an adjacent stream and a reservoir have also been identified. Another series of building remains are of uncertain function but are probably associated with the mining. *Journal of the Mining Heritage Trust of Ireland*, 1, 2001, 67-76.

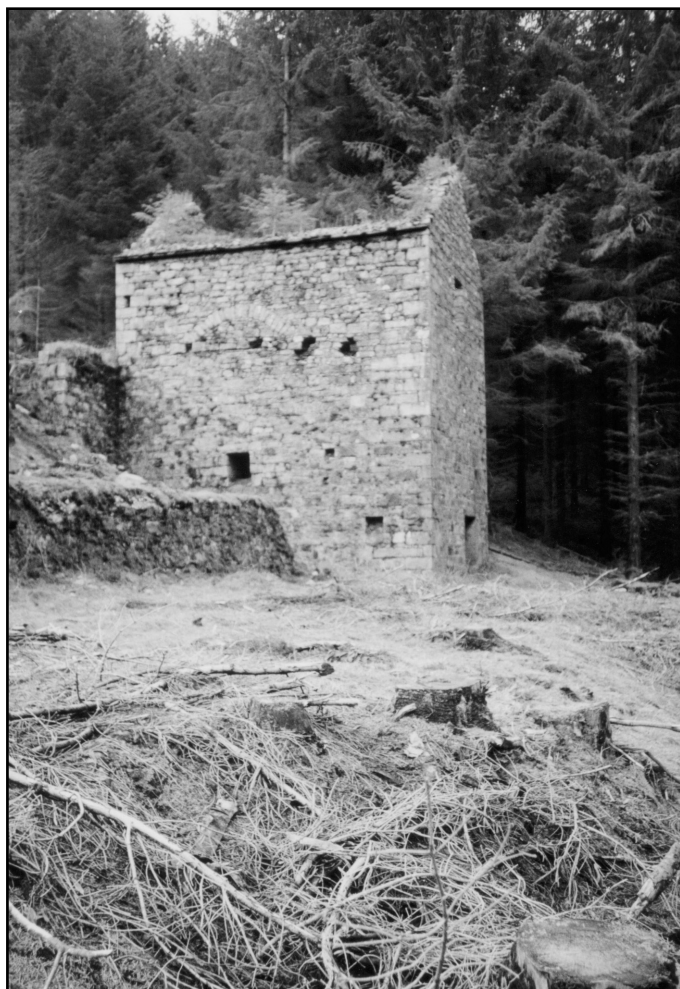
*Above: East wall of New Crusher House with the remains of the wheel pit in front*

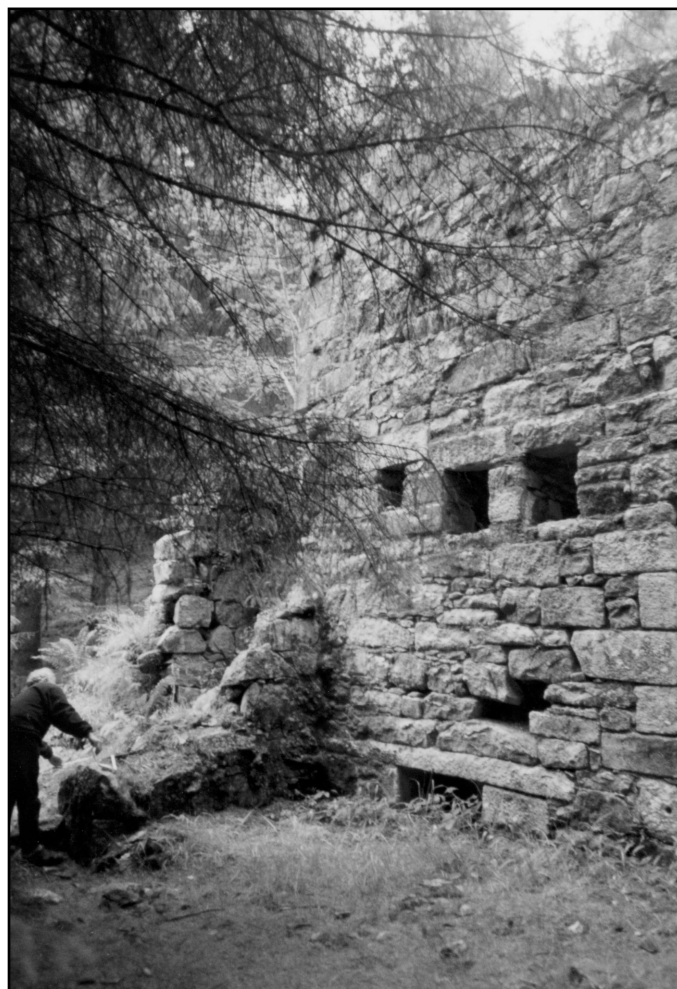
*Above right: North wall of Old Crusher House showing apertures for the weighted levers*

the main features can still be seen. The wheel pit is complete and the North wall has apertures for the weighted levers that applied pressure to the rolls. The Doorway on the North side is in urgent need of attention, as the masonry on the West side has collapsed, leaving the very large stone lintel unsupported. If this were to fall the entire North wall would become unstable.

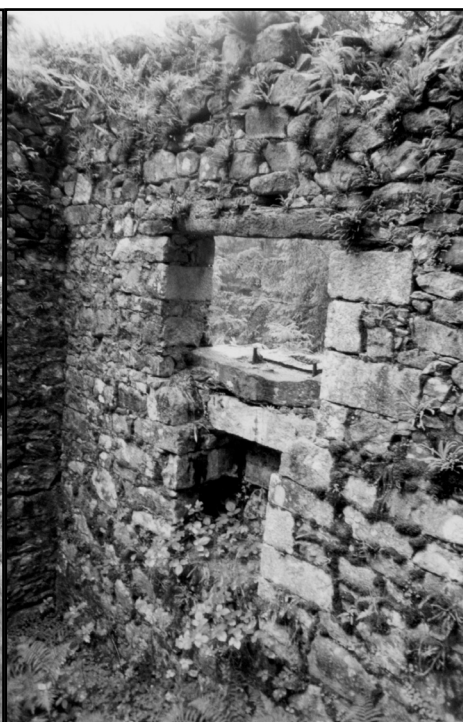
*Below middle: Old Crusher House. View from inside showing fixing bolts for the wheel bearing set in the East wall*

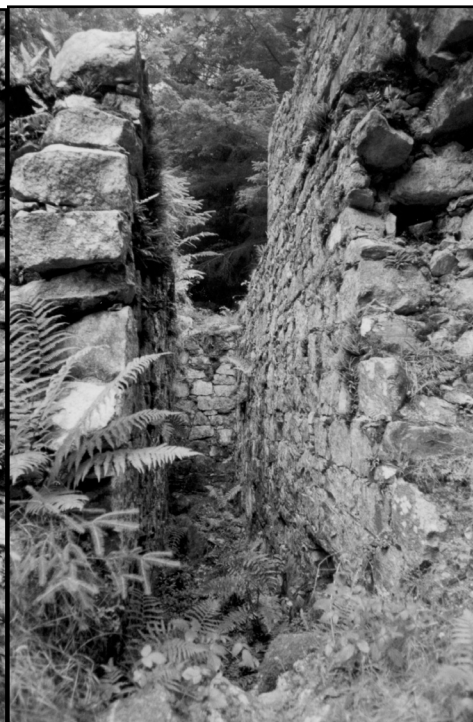
*Below right: Old Crusher House. The wheel pit looking South*

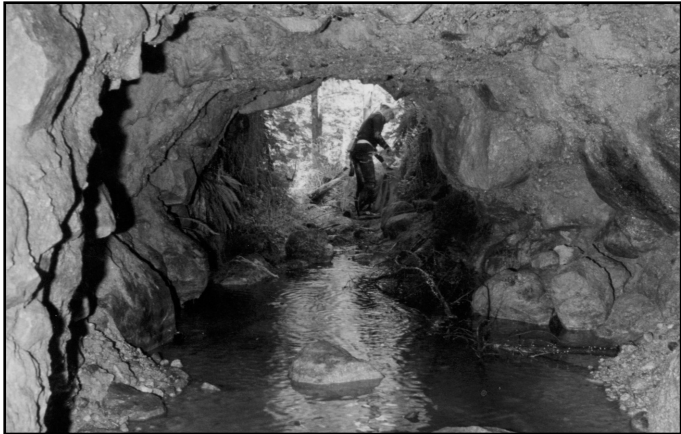
*Top left: Looking out of adit number 1      Bottom left: Coming out of deep water at the beginning of adit number 2*  
*Right: Avoiding damage to the formation by traversing the wall, near the end of adit number 2*
